Name Of Dam: SMITH RIVER DAM
Location: HENRY COUNTY, VIRGINIA
Inventory Number: VA. NO. 08913

PHASE I INSPECTION REPORT NATIONAL DAM SAFETY PROGRAM

Name of Dam: Smith River Dam, Va. No. 8913

Date of Inspection: May 1, 1979

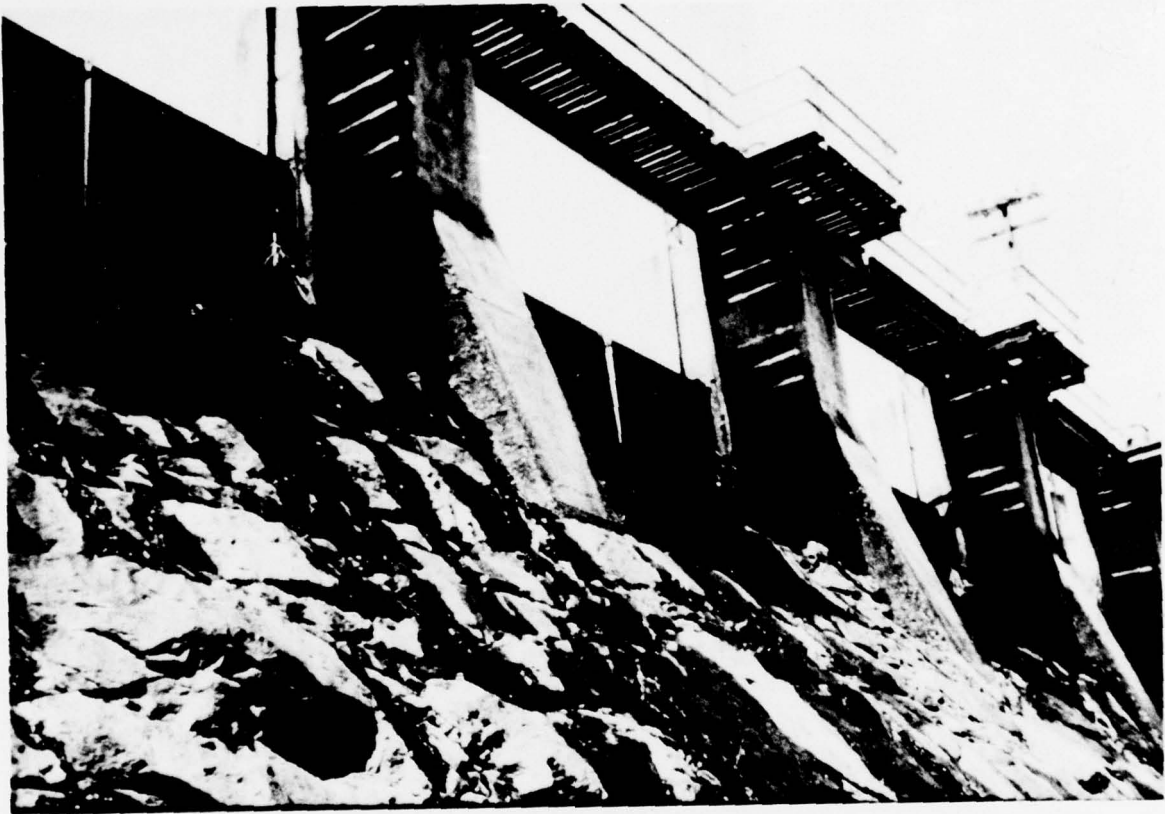
Considerable leakage was passing under and around the seals of the crest gates, particularly for Gates No. 7 through 14 numbered from the right abutment. The seepage flow ranged from less than 1 gpm to more than 100 gpm (Gates No. 8 and 11). The structure surface shows no apparent seepage along the face below the level of the gates. However, seepage was noted at the right abutment just downstream from the building.

CLOSE-UP CATWALK AND GATE SECTION

7.2.3 The concrete sill along the spillway crest should be repaired to minimize leakage through the crest gates and protect the crest from further deterioration.

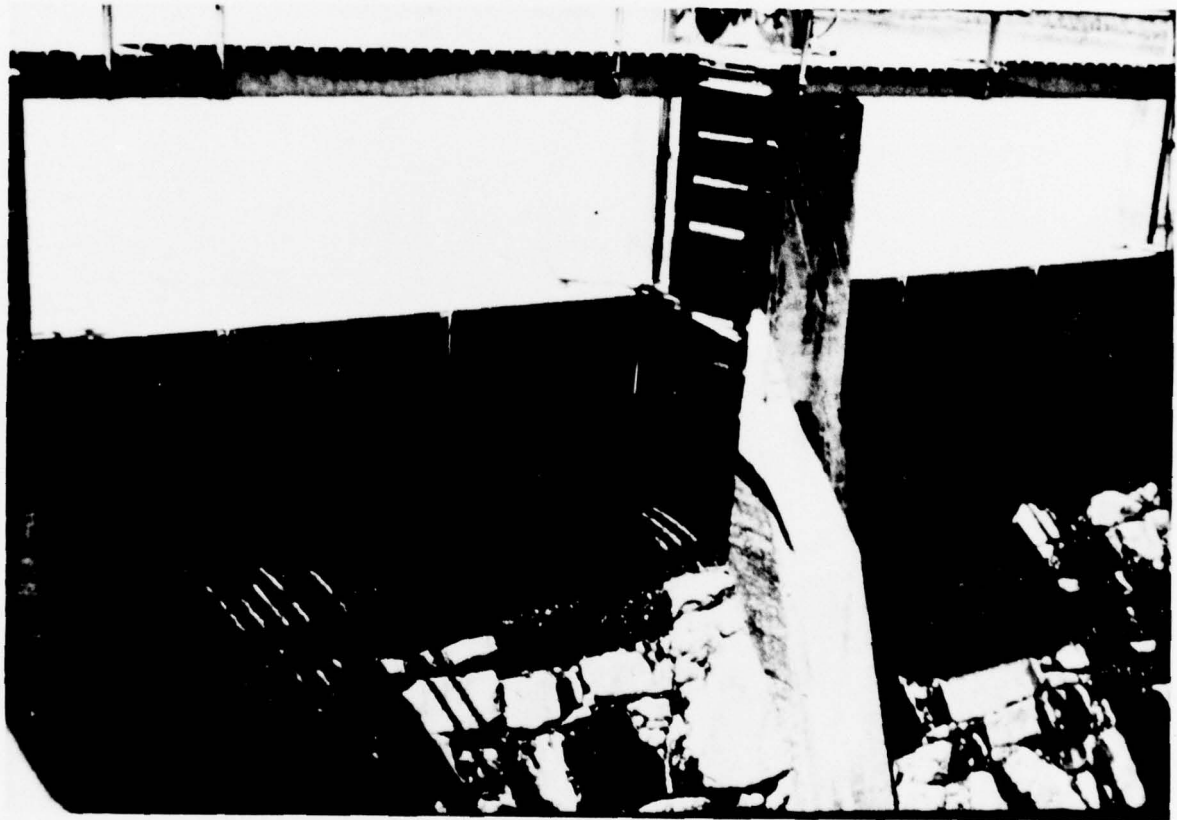
CLOSE-UP GATE

Leakage was passing below the spillway crest gates, particularly between Gates No. 7 through 14 numbered from the right abutment. The estimated leakage flow ranged from less than 1 gpm to more than 100 gpm. The greatest flow appeared to occur at Gates No. 8 and 11.

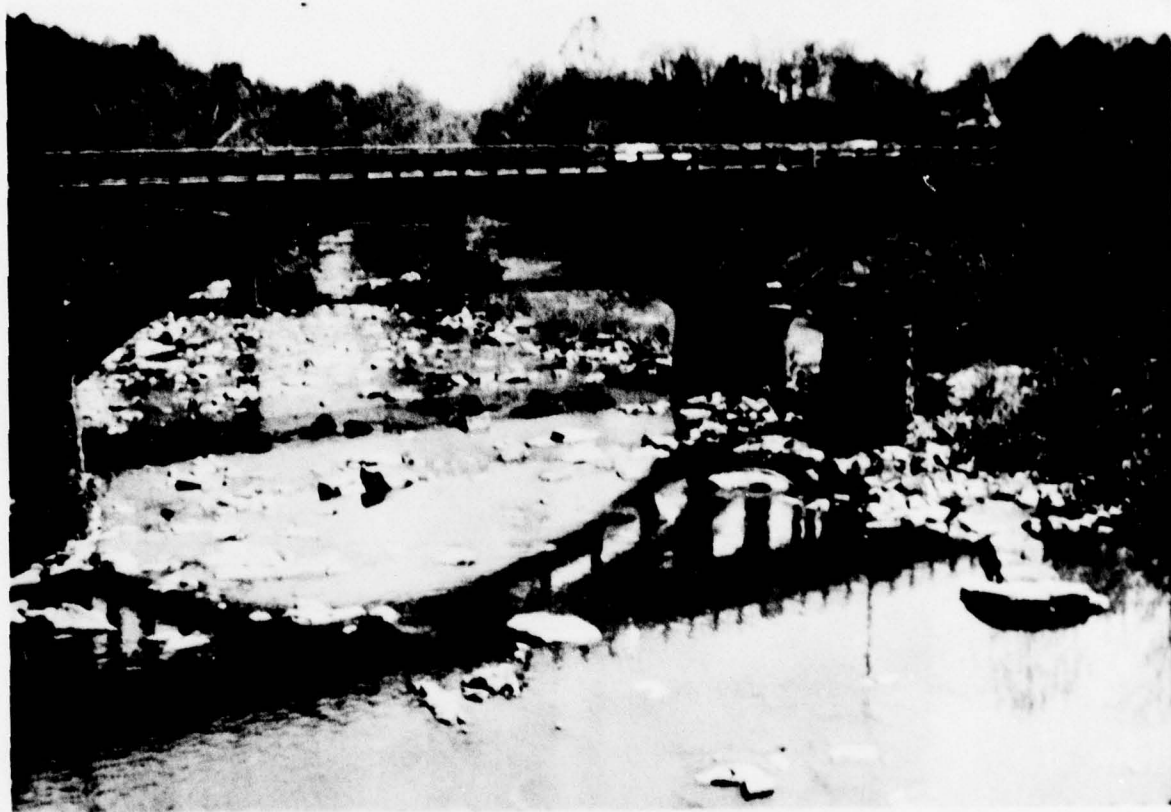
3.2.3 Downstream Area: The stream is stable with a rock bottom showing essentially no signs of erosion or scouring. A highway bridge crosses the river some 100 ft to 150 ft downstream. The bridge decking is at the approximate height of the top of impoundment. The downstream slopes are approximately 2:1 and the stream width is constant for some distance downstream. The only debris noted downstream were rocks, as can be seen in pictures in Appendix II. It was also noted

DOWNSTREAM VIEW
